**NASA
Technical
Memorandum**

NASA TM -86529

**COMPUTED TOMOGRAPHY FOR NON-DESTRUCTIVE
EVALUATION OF COMPOSITES: APPLICATIONS
AND CORRELATIONS**

August 1985

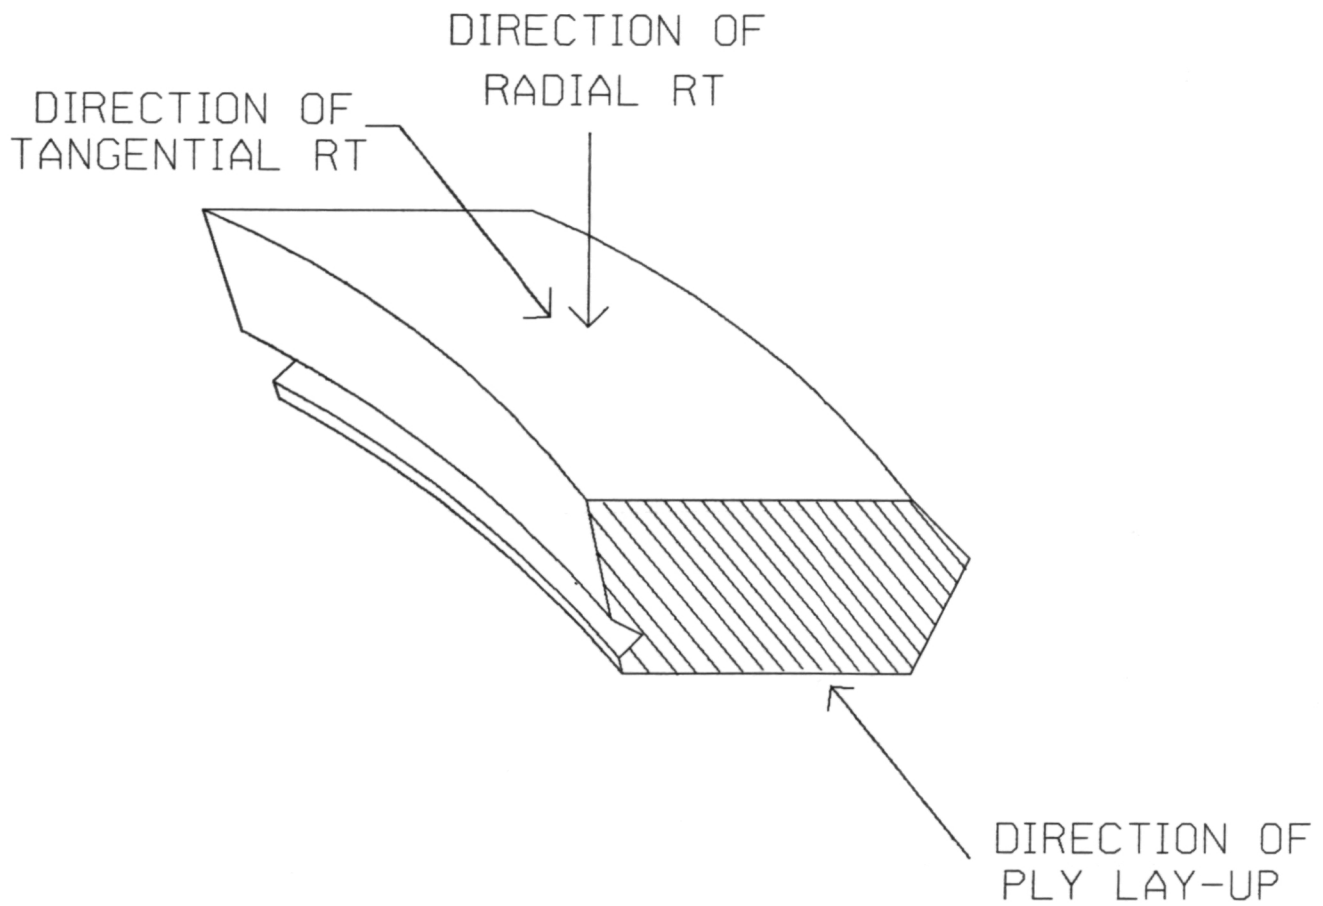
The initial radiographs of the unfired segments disclosed slight film-density changes which were correlated to visible cloth patterns and cloth-to-cloth lacing patterns in the segments. Several other film patterns were traced to visible surface conditions. Uniform light and dark bands which ran the entire length of the segments were initially attributed to sample geometry effects. Finally, several slight film-density variations were noted. Additional radiographs of the unfired segments, taken in radial and true tangential planes, were examined to investigate these anomalies (Figs. 26, 27, and 28).

Figure 26. SRM radiographic planes. (To eliminate superpositioning between plys, true tangential RT was applied.)
